The impacts of land-use changes on the recovery of saltmarshes in Portugal

Diana Almeida^{a,*}, Carlos Neto^a, Luciana S. Esteves^b, José Carlos Costa^c

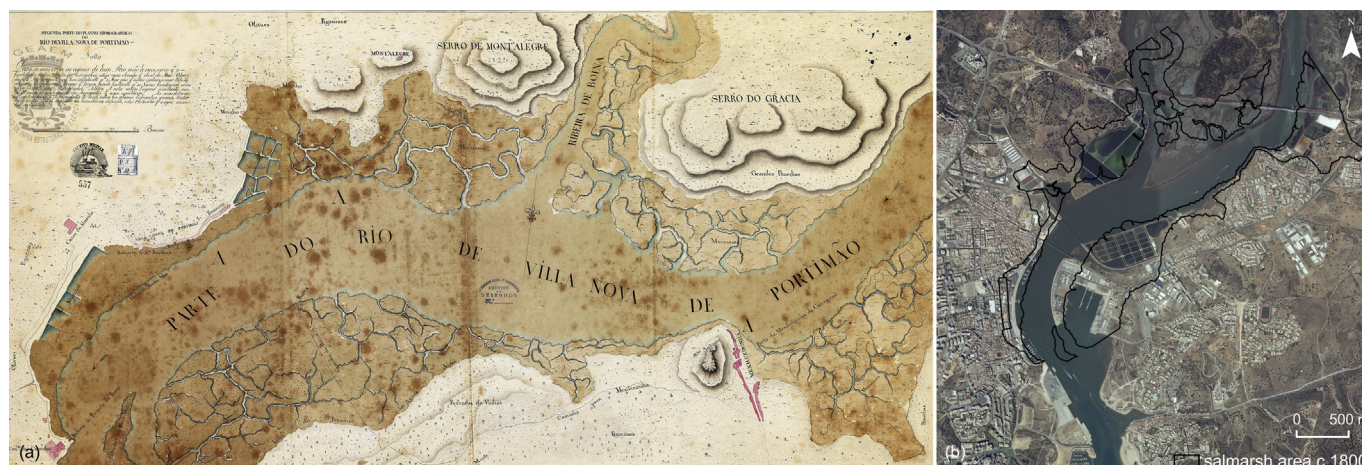
Fig. 2. a) Arade River and surroundings in c. 1800 (Baltazar de Azevedo Coutinho, Geographic Military Institute-IGEOe), b) saltmarshes of Arade River in c. 1800 over ortophotomap of 2010.

The analysis of land cover c. 1800 (Fig. 2a) indicates that wetlands have been progressively urbanized in the area of Portimão (Fig. 2b). Geoprocessing of historic maps revealed that saltmarshes occupied an area of 242 ha c. 1800. Analyses of aerial photography indicate that in 2010 the total area of saltmarshes was 118 ha. Therefore, 51% of saltmarshes in the Arade River mouth were lost between 1800 and 2010. Further analyses taking into account other areas along the Arade River indicate that in total 65% of the saltmarshes were lost between 1800 and 2010. Reclaimed areas along the river Arade correspond to excavated old marshes, filled with estuarine mud and protected from tidal influence, with the purpose
